Preservation of Materials in Outdoor Museums

ABSTRACT: Historical Village of Hokkaido (*Hokkaido Kaitaku no Mura*) is a regional outdoor museum of popular life. Opened in 1983, its 27 houses now exhibit some 15,000 folk materials. This report describes the activities and conservation problems of this outdoor exhibition, with special reference to variations in interior climate caused by the differences in construction materials, results of the application of different anti-corrosive agents to iron tools, tests on the fading of dyed fabrics and the control of insects, dust and visitors.

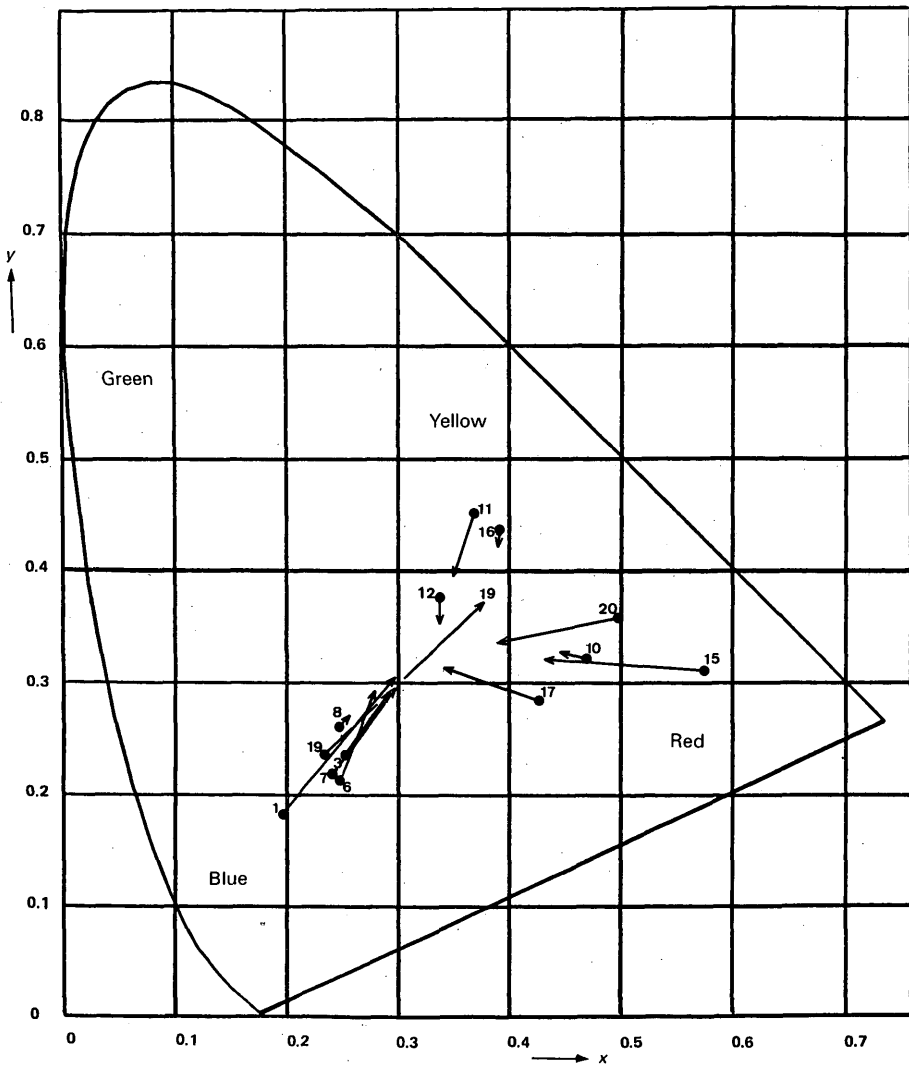
Fig. 5. Degree of fading of dyed cloths, using the CIE 1931 Standard Colorimetric System.

The fading rates of dyed fiber materials are indicated in Table 3. Some fading is illustrated (Fig. 5). Dyed fiber materials exposed to strong sunlight have faded. Cotton and hemp materials dyed dark blue and red have faded remarkably. The Standard Specification of Color (JIS Z-8721) was used to determine the Y - xy value in the colorimetry of dyed cloths. Variation of Y - xy value was observed by compar-

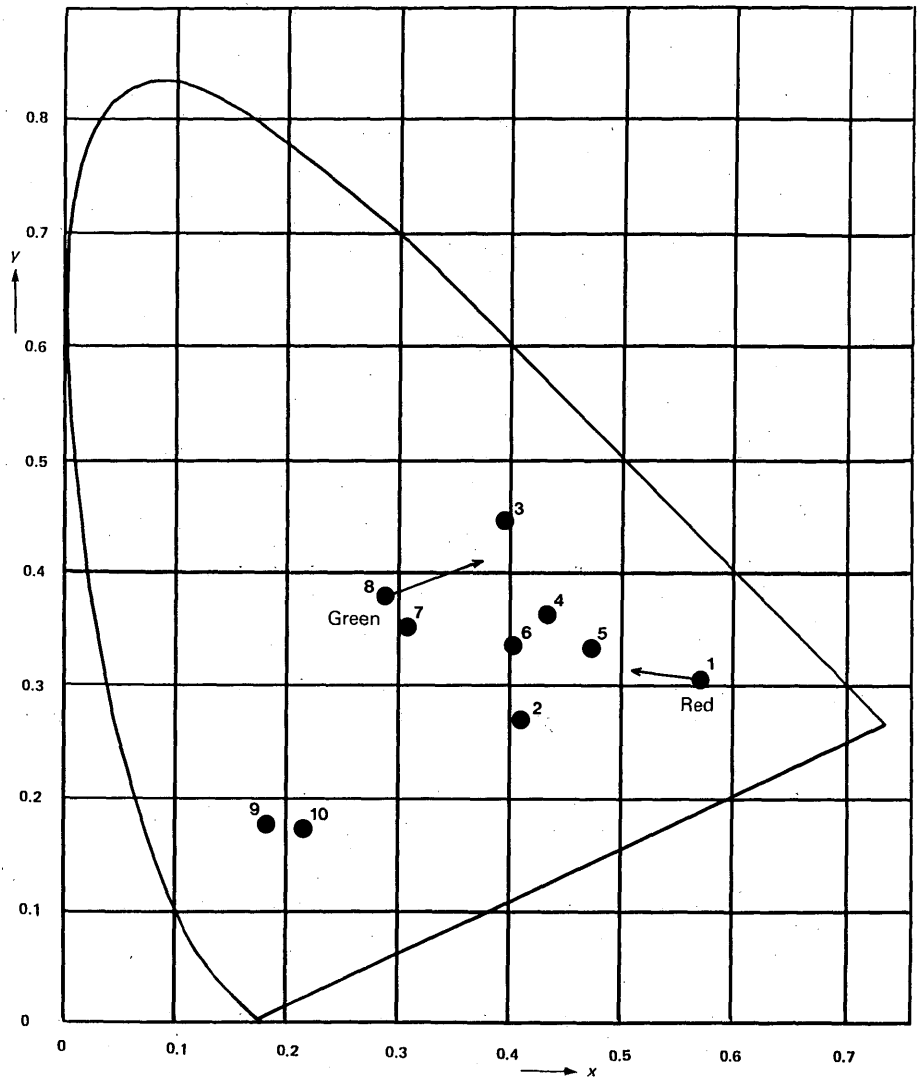
Fig. 6. Degree of fading of direct dyed cloths after 300 days of exposure in the Higuchi's farmhouse.

The rates of fading in each location were different, but the fading of samples exhibited the same tendency (Table 4). The fading of red and dark green was the highest in direct dyes, and dark blue and brown was the highest in vat dyes (Figs. 6 and 7). A small amount of fading occurred in other colors, but it was impossible to determine their colorimetry using the Standard Specification of Color method.

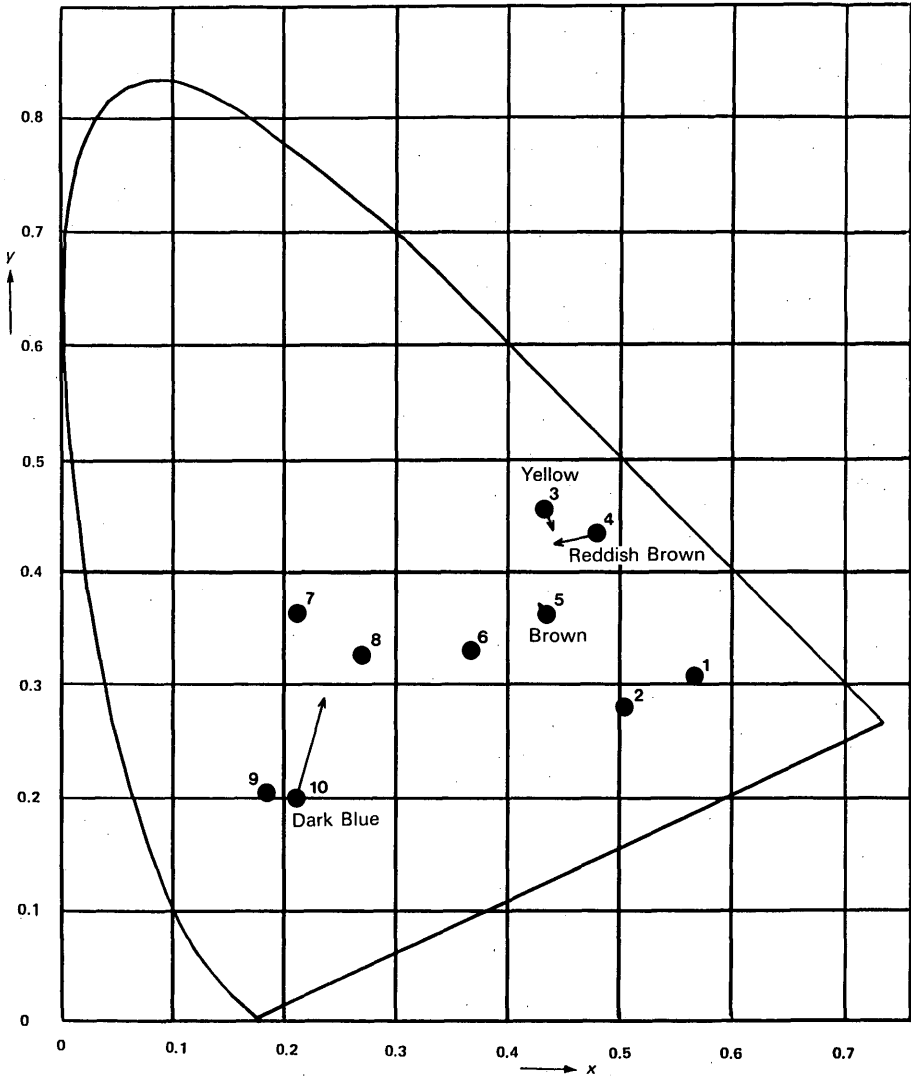
Fig. 7. Degree of fading of vat dyed cloths after 300 days of exposure in the Higuchi's farmhouse.

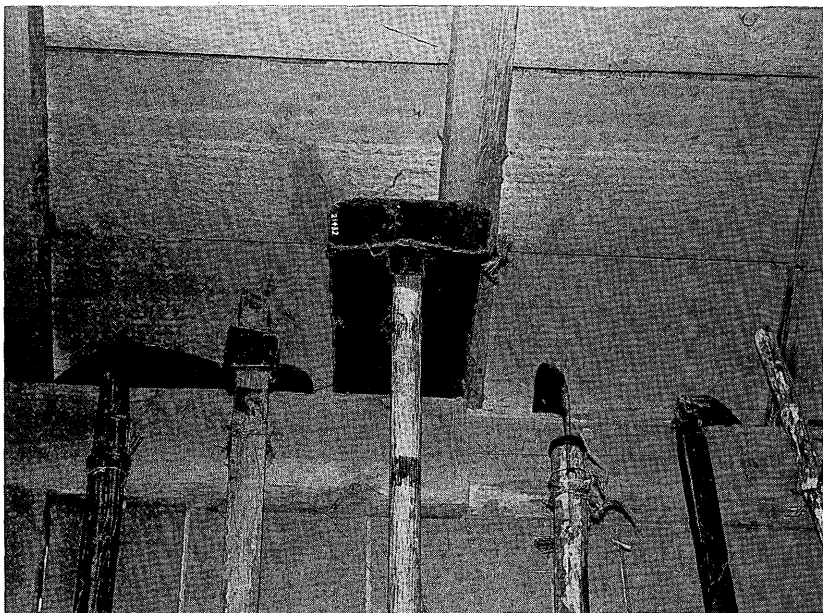
Fig. 12. The rusting of iron tools stored under eaves.

As mentioned above, the exhibits are displayed under extremely harsh conditions. Many of the iron artifacts are rusted, and particularly some in the outdoors are heavily rusted. Many artifacts displayed buried under ashes in a hearth and a brazier are also heavily rusted (Table 1). Those displayed elsewhere are much less rusted. This tendency can be demonstrated for both the artifacts treated with an anti-corrosive chemical and those not so treated.

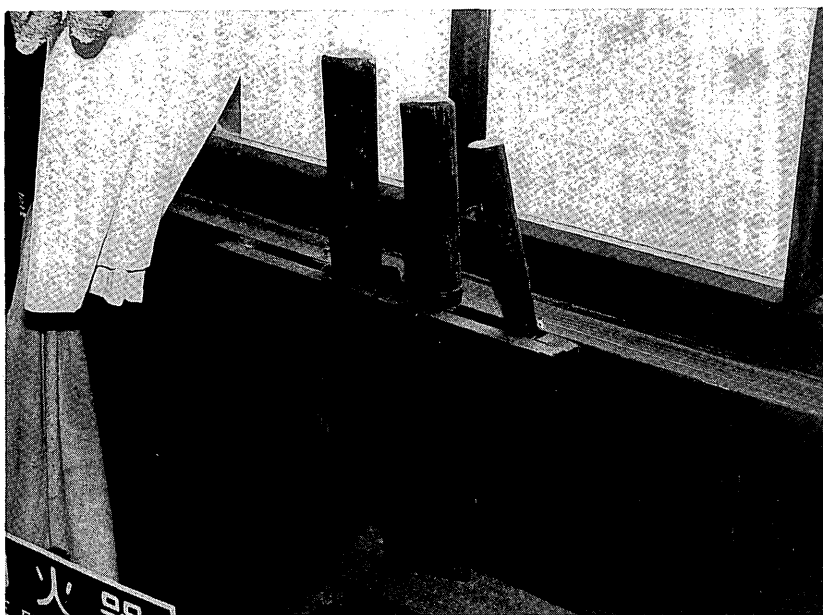
Fig. 13. The rusting of iron knives in a window rack.

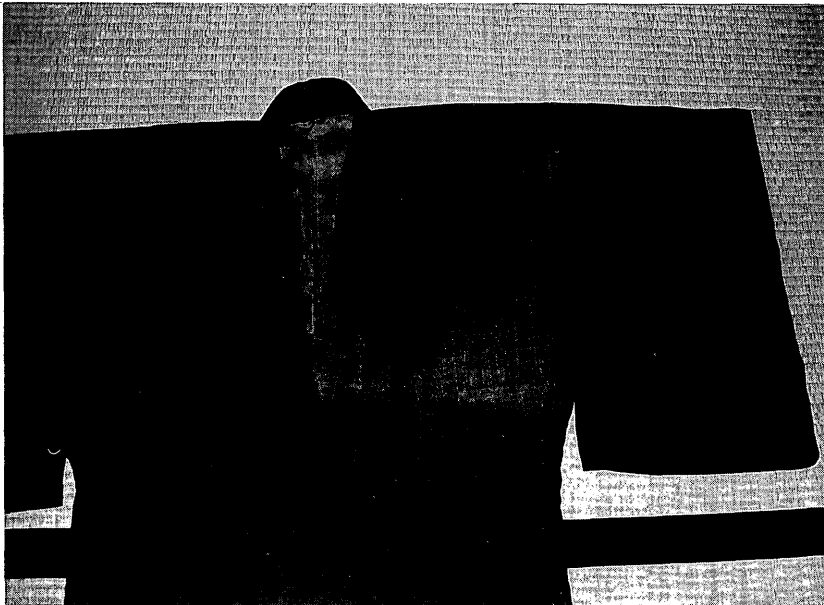
Fig. 15. Fading of *kimono*, after long display.
