## Accessing the Ancestor Architecture : An Examination of the Galleries of Chavín' s Building C Vicinity

**John W. Rick**

**Miguel Ortíz**

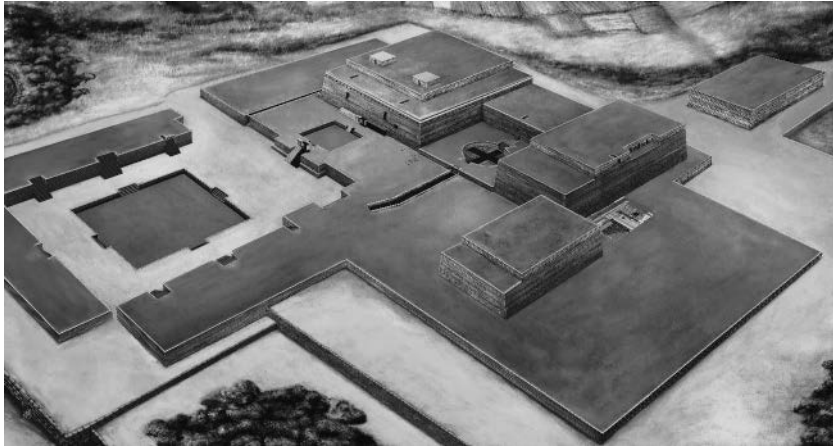
**Figure 2-1** Perspective recreation of Chavín de Huántar in the Black and White Stage, ca 850–550 BC cal, looking to the SSW; the large square plaza is 49 m on a side. The excavation area in the north esplanade of Building C is visible in the right central area, Building C is up and left, and Building D is down and left from the excavation area. ©Programa de Investigación Arqueológico y Conservación de Chavín de Huántar (PIACCH), drawing by Miguel Ortíz.

All galleries thus far known specifically from Building C are from the Loco Complex, located just below the highest part of the building (Figure 2-1). Like most of the galleries of Chavín, the Loco Complex is a group of galleries that are physically and logically linked, yet arguably separable as modules that have their own distinctive layout. In the Loco Complex, there are three galleries: Loco, Mirador, and Capilla (Figure 2-2). The Complex takes the name of Loco because that gallery is central to the other two, it shows signs of having parts that are early, and it is the largest and most complex. This arrangement of ‘galleries in a complex’ was recognized implicitly by Tello (1960: 88–89), in his representation of the galleries of Chavín in an elaborate map that projected several unknown galleries based on presupposed bilaterally symmetrical layout in conjunction with a known gallery. One newly discovered gallery of the Loco Complex, Gallery of the Capilla, shows that in cases Tello and his team were correct in this assumption.

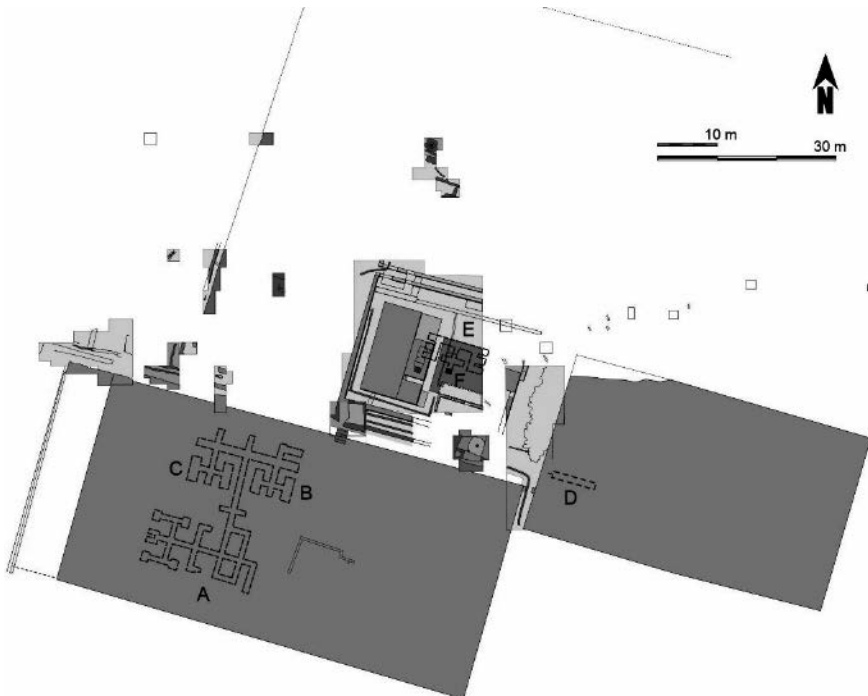
**Figure 2-2** Plan view of Building C (lower left), esplanade area (center), Building D (lower right). 2009–2019 PIACCH test and area excavations are shown by cardinal-direction-oriented rectangular areas. Letters indicate galleries: A, Loco; B, Mirador; C, Capilla; D, Early D; E, Esplanade; and F is Black and White Stage plaza. ©PIACCH

north of it (Figures 2-1 and 2-2). These are a combination of previously known galleries and those that have been discovered in major investigations undertaken from 2009 to 2022 as a major subproject of our Programa de Investigación Arqueológica y Conservación de Chavín de Huántar (PIACCH). This long-term archaeological effort, established in 1995, eventually made a major commitment to understand Building C and its vicinity in a multi-pronged effort that included comprehensive attention to a specific space within the site that was representative of the monumental core of Chavín's ceremonial center, and the development of archaeological and conservation protocols specifically adapted to the archaeological and environmental characteristics of Chavín. We planned to pay attention to the known galleries of the building but did not expect to encounter additional galleries. The discovery of at least three unanticipated galleries, together with the known ones, provides not only additional architectural, chronological, and artifactual data about Chavín's uniquely extensive gallery systems, but also a perspective on their construction and use as well as the intrinsic relationship between galleries and the logic and intent of the growth of Chavín during the Formative period.

Thus far one clear plaza has been found in the esplanade, located well to the east of the E-W centerline of Building C (Figures 2-2 and 2-9). It has a history that may span most of the Black-and-White Stage, and may have been accessible through the brief

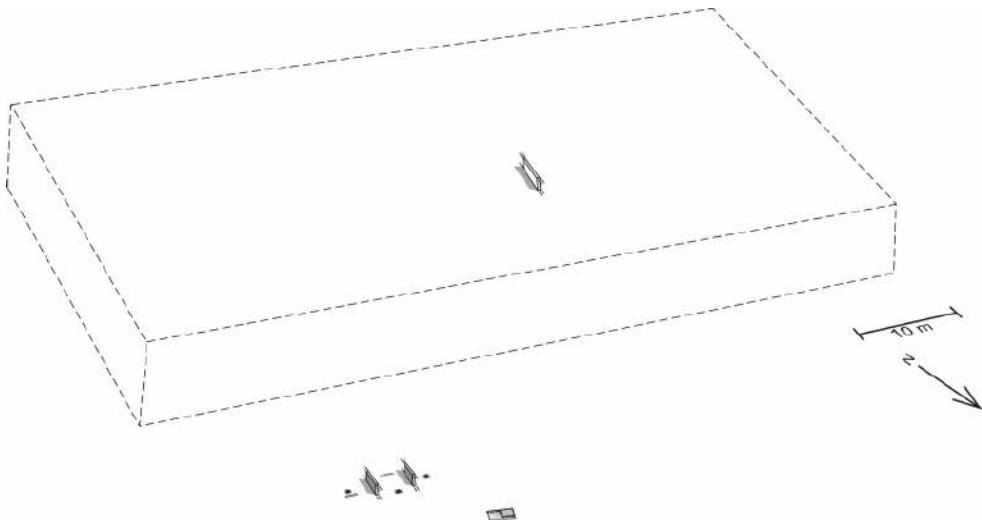
**Figure 2-3** Earliest moment of gallery-related architecture in Building C environs. Surface level walls, canals and pits represent surficial architecture that will be incorporated into later gallery construction. Approximate  $^{14}\text{C}$  age of architecture is set by date AA103665 in Figure 2-9, ~1300–1100 BC cal. © PIACCH, drawing by Miguel Ortiz.

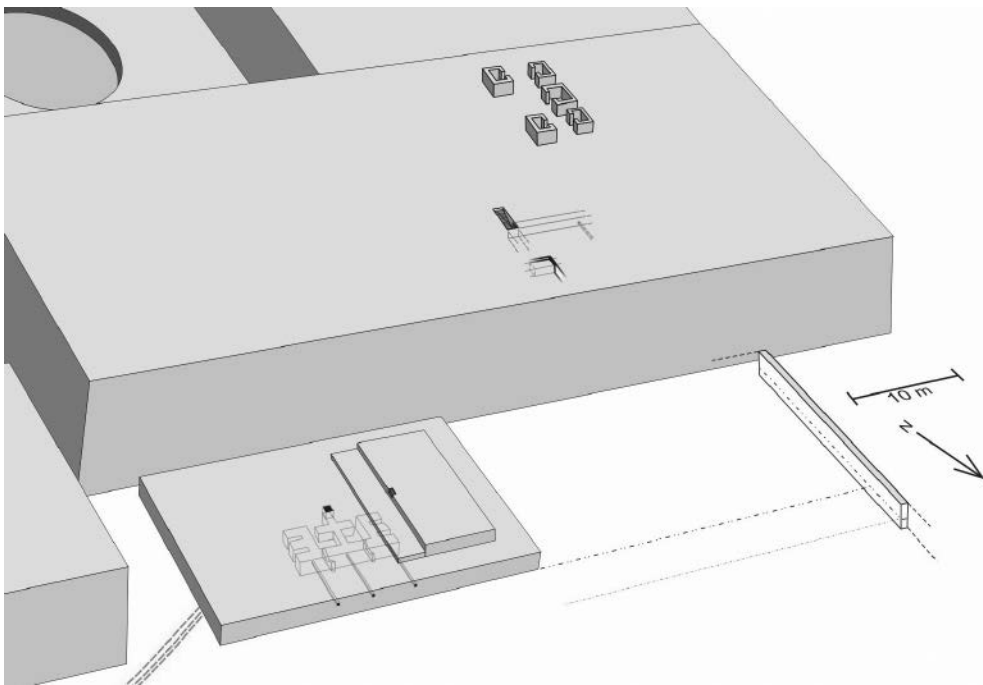
**Figure 2-4** The earliest evidence of gallery construction known from Building C and esplanade area: Loco Rooms and early gallery corridors and descending stairs visible on top of Building C; Esplanade Gallery installed in esplanade platform. Approximate building date, especially for the Esplanade Gallery may start in the 1200–1000 BC cal range, as determined by preceding structure dates, use date AA103664 (approximately 1000–770 BC cal) and use termination (fill) dates AA103669 and AA103670 for early Loco corridor (approximately 1050–800 BC cal). ©PIACCH, drawing by Miguel Ortíz.

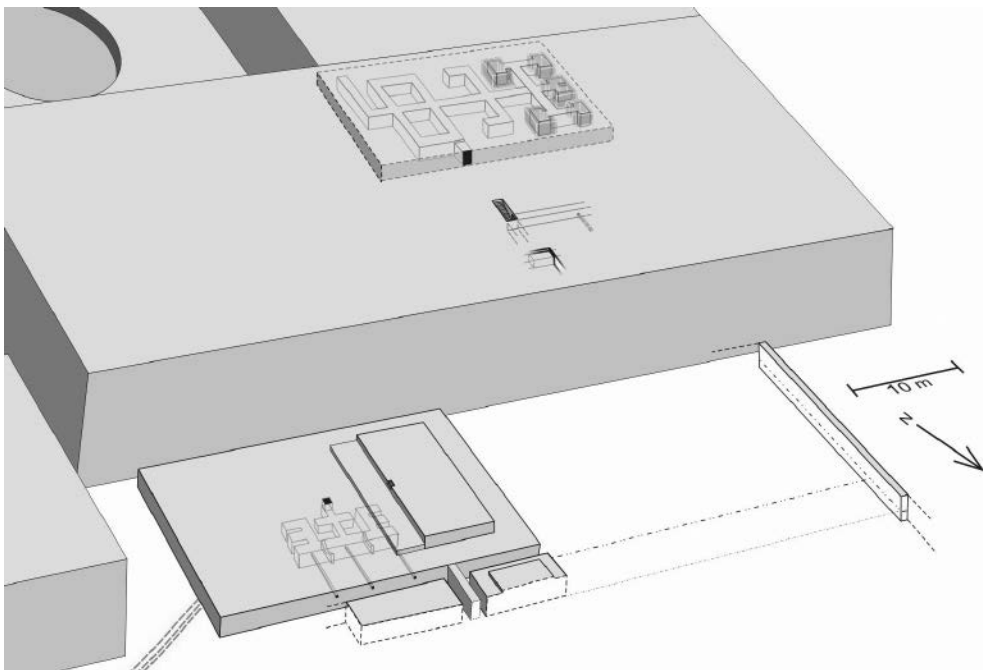
**Figure 2-5** An increase in Building C height allows incorporation of Loco Rooms as parts of the new Loco Gallery, with corridors to the south. Esplanade Gallery likely remains in use, probably relates to early Black and White Stage times around ~850 BC cal. ©PIACCH, drawing by Miguel Ortíz.

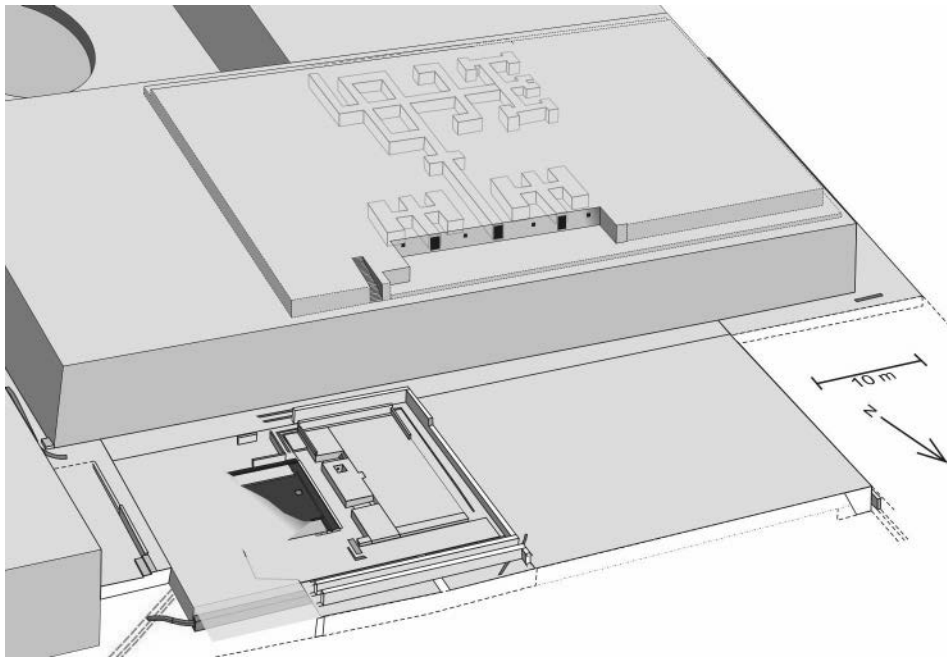
**Figure 2-6** Full extension of Loco to east and north; additions of bracketing Capilla and Mirador galleries, entombment of lower Loco and Capilla, gives a no-earlier-than-date of end-use dates of 1050–800 BC cal. Esplanade Gallery may be accumulating filtration sediments, having occasional visitation. Probably on the earlier side of 850–550 BC cal, date AA62773 (Figure 2-9) may be a construction date for northern Loco at about 900–800 BC cal., suggesting most Loco construction over in earlier Black and White Stage. ©PIACCH, drawing by Miguel Ortíz.

Mirador is a much smaller gallery, evidently constructed in the last major construction phase of the Loco Series (Figure 2-6). Kembel's analysis of construction phases suggests it was built in one construction event, leaving no telltale seams. The gallery appears to be completely clean of deposits, although there is no record of its excavation nor materials encountered within it. It does appear to be relatively intact and free of reconstruction.

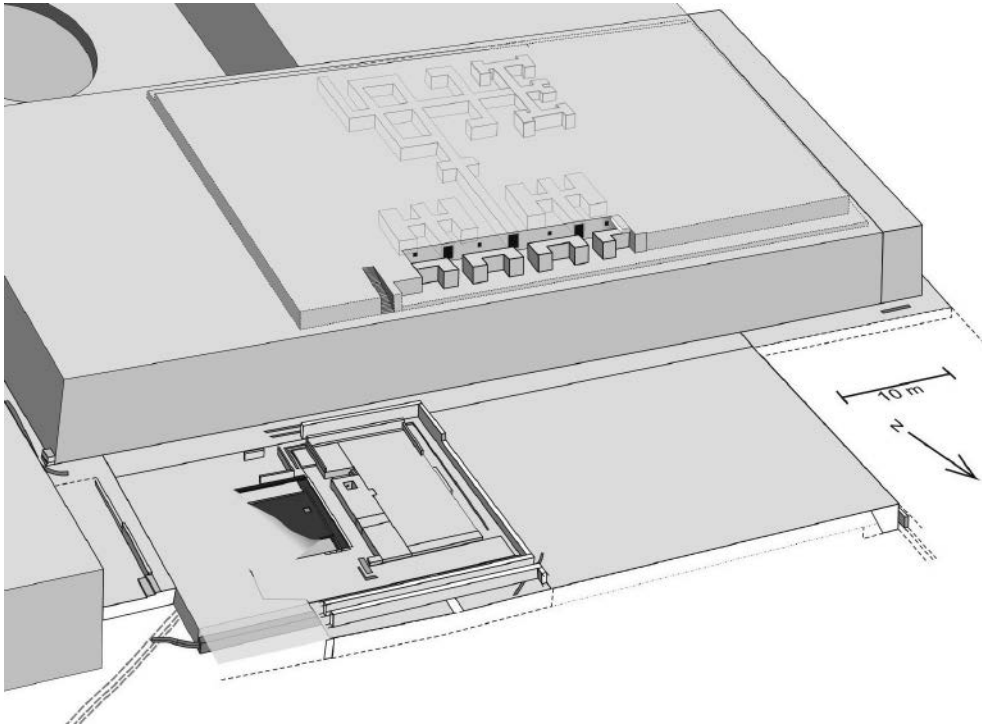
**Figure 2-7** Last Chavín construction events in Building C, including building blocks that form Loco's entranceway E-W corridor and fill most of Loco's gallery patio; Building C extended westward in response to western façade collapse linked to ~550 BC cal widespread likely seismic damage in Chavín. © PIACCH, drawing by Miguel Ortíz.

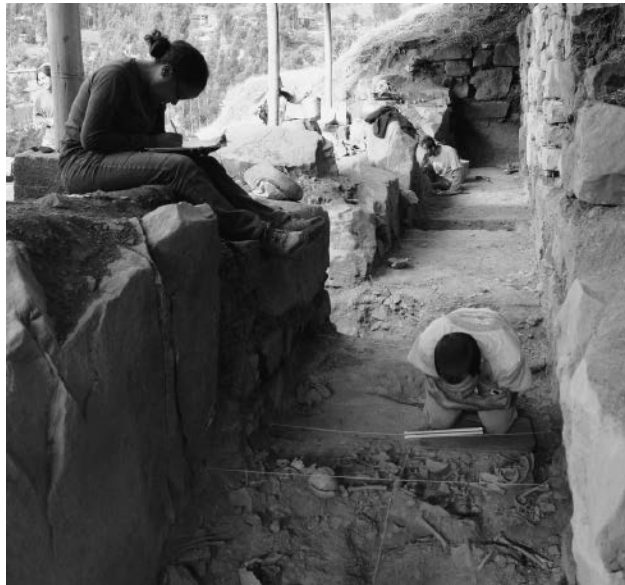
**Figure 2-8** View down the Loco Complex entranceway E-W corridor, looking eastward from the entranceway to Capilla Gallery. Mixed human and animal bone concentration visible in the foreground, stratigraphically highest of a number of over-floor bone layers. ©PIACCH

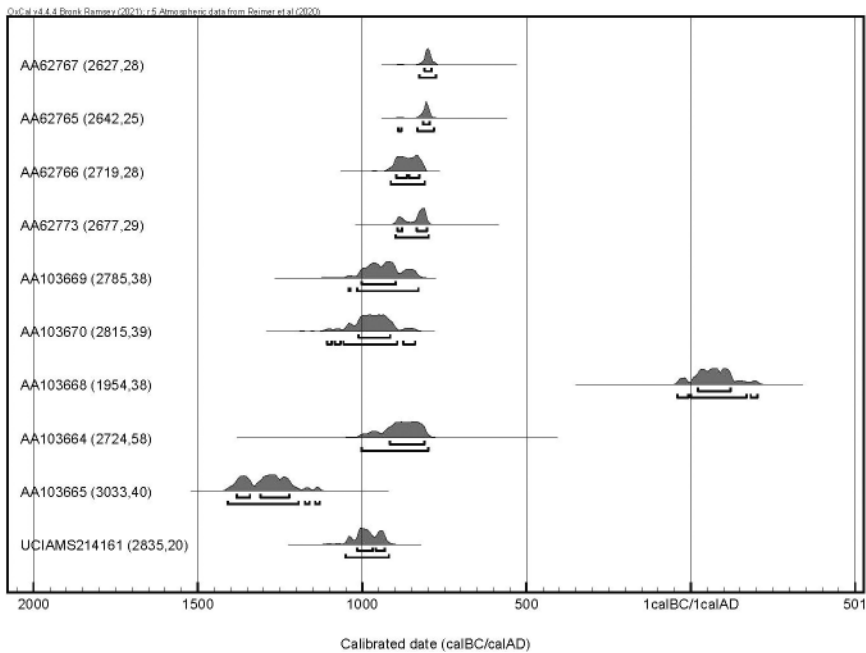
**Figure 2-9** Radiocarbon determinations from relevant contexts in Building C environs galleries. The top four dates from building mortar in Loco; the first three are considered renovation dates from re-mortaring of walls at some unknown time after construction. The fourth date (62773) may be a construction date for the northern Loco Gallery. 103669 and 103670 are dates from the massive fill of the lower Loco corridor. 103668 is from charcoal in the post-Chavín bone layer in Loco entranceway E-W corridor. The lowest three dates are Esplanade Gallery: 103664 is gallery use deposit, 103665 is deep subfloor deposit, 214161 is a less deep pre-Esplanade deposit. Upper brackets are 1 sigma ranges, lower brackets are 2 sigma ranges. ©PIACCH, graphic by Daniel Contreras.

The probe was terminated due to the congestion of these architectural features we chose not to remove, and cultural deposits continued below. Although reliable material for dating was scarce, we did obtain a date of 1046–837 BC cal (Figure 2-9: Lab no UCIAMS214161) from well below the gallery floor.

The Loco Complex, following Kembel's intricate and insightful analysis (Kembel 2001, 2008) starts with five surface rooms in a symmetric arrangement, the largest and most central of which is reminiscent in orientation, configuration, wall thickness, and within-building placement to the central chamber of the Lanzón Gallery, in adjacent Building B. The distance and varying orientation (3 Loco Rooms are entered from architectural east, two from architectural west, while the only known entrance to lower Loco/Capilla, is from the architectural south) could indicate that their above- and below-ground conditions were involved with behaviorally and spatially separate functions. These rooms are probably built on the same upper mound surface that would have immediately overlain the beams of lower Capilla segments, and thus were probably approximately contemporary. The intentional fill of the previously mentioned “Lower Loco” corridor produced two near-identical dates with ranges of about 1050–800 BC cal (dates 103669 and 103670 in Figure 2-9), which likely provide a termination date for the

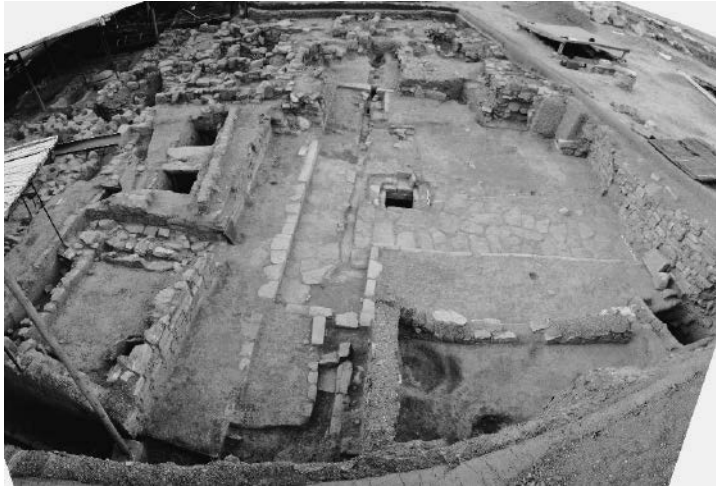
**Figure 2-10** Overview of complex, mostly Chavín age esplanade architecture including the stone-floored plaza, the entrance to Esplanade Gallery in center, curbs and lateral plaza structures. The small surface canal in the center of the image is running immediately above the beams of the Esplanade Gallery. ©PIACCH

small square stone-lined pit was constructed along and immediately overlying the northern edge of the entrance's frame (visible in Figures 2-10 and 2-14), a feature reminiscent of square and circular stone-lined pits frequently observed in the Esplanade area that appear to mark, or reach stratigraphically backward to important earlier structures. Still later, a post-Chavín wall had been built directly above the entrance, which together with the cover stone and a lack of post-Chavín materials other than those slightly slumping into the entrance strongly suggests that the gallery had remained sealed since Chavín times. The gallery was found with silty/clayey sediments filling most of the gallery's height, lying very flat and clearly water deposited. Again, the sediments bore no suggestion of disturbance of any type.

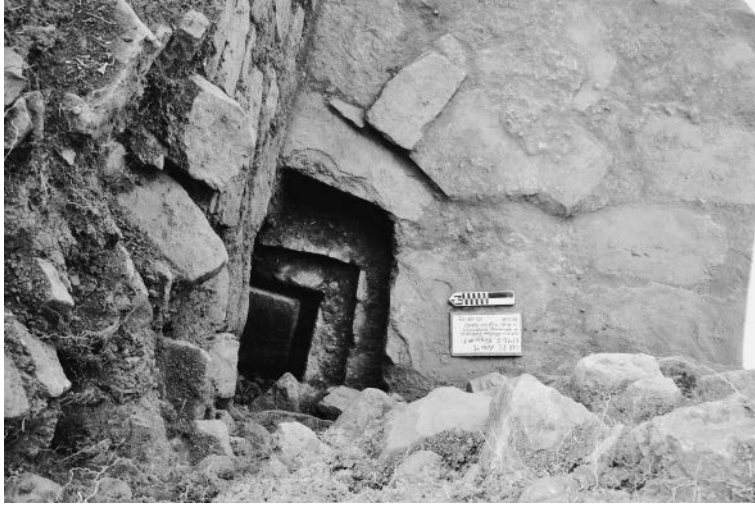
**Figure 2-11** Entranceway to Esplanade Gallery as found, with double insets, and one large offset stone slab still present as a remnant seal in the entrance. ©PIACCH

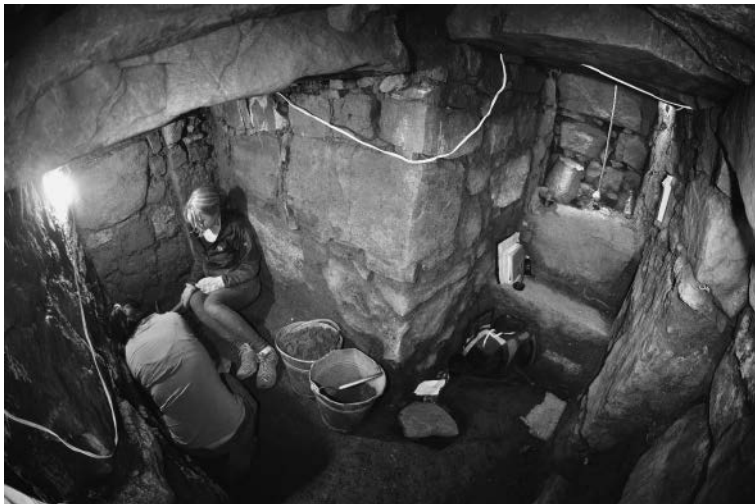
**Figure 2-12** Interior of Esplanade Gallery during excavation, with entranceway and high steps descending on the right. The clear architectural seam of abutted gallery and the prior surface wall behind right excavator. ©PIACCH

A rather different situation was found in the alcove lying to the right (east) of the entry corridor. Here seaming and different styles and fineness of stonework clearly defined abutted, vertical wall segments (Figure 2-12). The situation was inadvertently clarified by an excavation carried out within the post-Chavín structure that overlay the gallery's entrance. A moderate-sized intrusion below that structure's floor was in evidence, and on the removal of the fill within it we came down on a wall which proved to be the backside of one of the above-mentioned abutted gallery wall segments. Most striking is that the wall is double-sided, and thus quite clearly is an old surface wall adopted as a gallery wall when the massive platform fill was added, raising the surface approximately 2 m, and accommodating the new gallery in its volume. It is possible that some or all these seams are related to continuations of the crossing walls previously discussed. Thus, there is clear evidence that the Esplanade Gallery was constructed in relation to pre-existing surface architecture, incorporating some walls, but undoubtedly dismantling others that did not fit the complicated gallery layout.

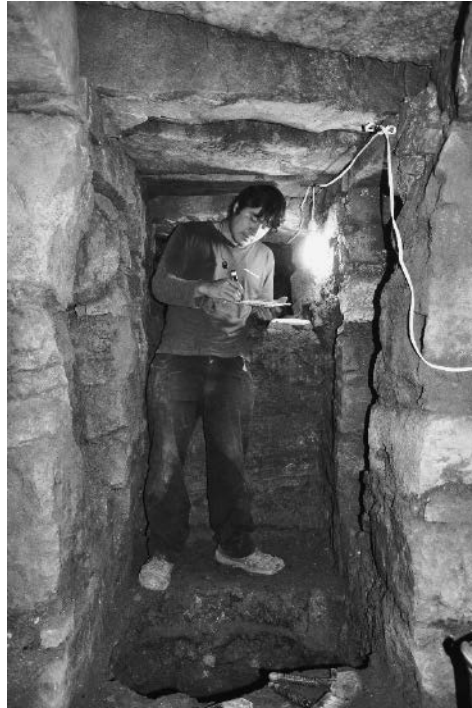
**Figure 2-13** Miguel Ortiz standing on the Esplanade Gallery floor, showing limited gallery height. Excavation in the foreground is an exploration of the pre-gallery canal and sub-canal deposits that produced date AA103665. (Figure 2-9) © PIACCH

the gallery – it is by far the lowest-roofed gallery in Chavín, and only the shortest adults in Chavín times could have negotiated its passages without stooping (Figure 2-13).

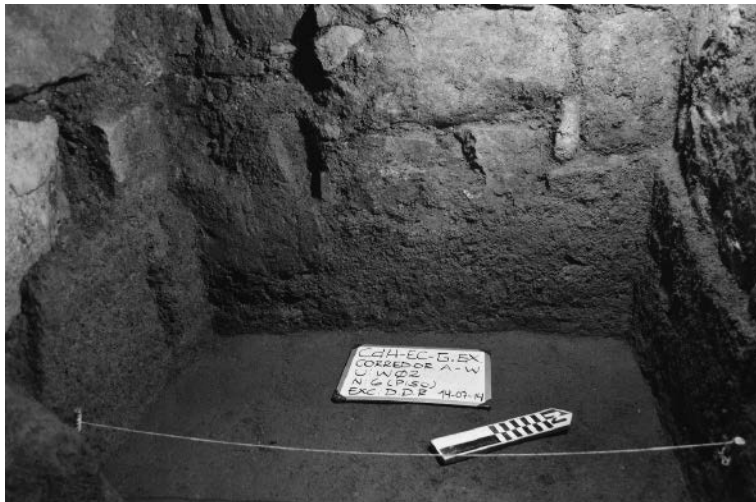
**Figure 2-15** Original plaster in the cell of the Esplanade Gallery ©PIACCH

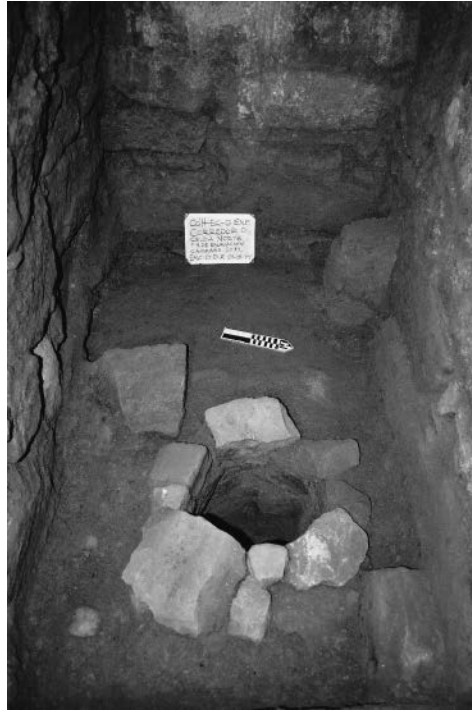
**Figure 2-16** Cylindrical stone-lined pit EA 05 in the Esplanade Gallery. The gallery floor has been removed and is shown at a lower level, highlighting the pit’s stone construction. © PIACCH

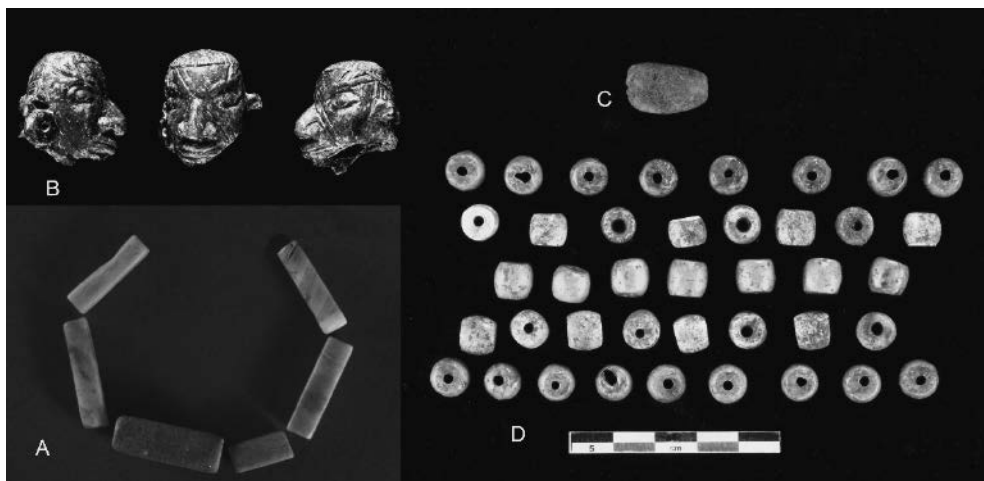
**Figure 2-17** Esplanade Gallery offering from filtration sediments well above the floor deposits. A. Six beads with rounded square cross-section; four are lighter colored *Spondylus* shell, two darker beads are lapis lazuli. B. Three views of ceramic head adornment, apparently a remnant medallion from a ceramic vessel. Note characteristic diagonal stripe across the face and enlarged nose typical of Chavín human faces. C. Turquoise bead perforated through long dimension, found with D. 24 hollow gold beads (First, third, and fifth lines of beads) and 16 shell beads (probably *Strombus*—second and fourth rows), most with remnants of red cinnabar adhering. Some gold beads show wear on perforation resembling stringing effects from long use. One gold bead tested at two locations averaged 95% gold, 5% silver, and <1% copper, by weight; red colorant adhering to gold bead was positively identified as cinnabar. © PIACCH

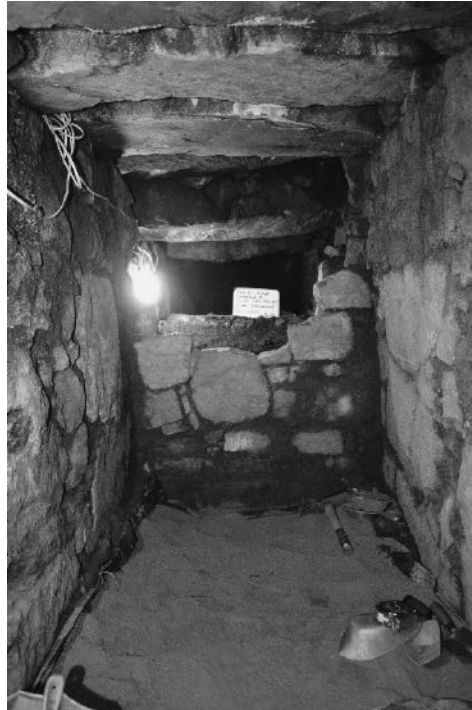
**Figure 2-18** West side of eastern blocking or sealing wall EA 02 originally built prior to the Esplanade Gallery, possibly rebuilt during gallery use. ©PIACCH

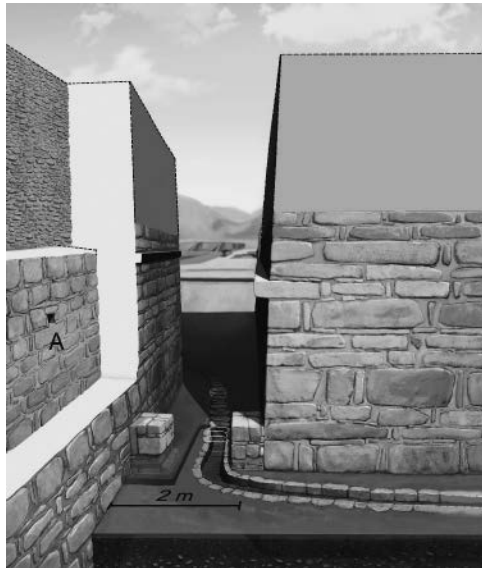
**Figure 2-19** Artist's reconstruction of the passage between Building C (right) and Building D (left). "A" designates the duct in the earlier façade of Build D which leads into the Early D Gallery. ©PIACCH, drawing by Miguel Ortíz.

A clearly finished exterior duct exit was found in the earlier façade (Figure 2-19), indicating that the duct had been built into the earlier façade during its construction; the packing of clay mortar in the outermost part of the duct suggests that the duct was blocked, and probably covered by the now-fallen outer façade. Although the duct clearance was small, we were able to introduce a tiny video camera into the duct, and after more than a meter of duct, the camera emerged into a much-enlarged duct running architectural E-W (Figure 2-20). After many attempts, the camera could reach a total of 9 m to the east, expanding into a gallery-like space of multiple meter width more than 3 m before encountering the gallery's east wall. The gallery-like space involves a meter lower floor level, and the ceiling height seems to jump upwards at the same time the floor

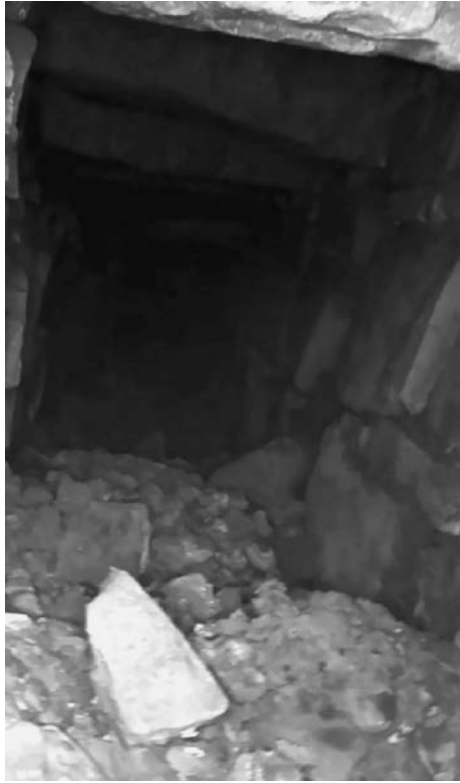
**Figure 2-20** Interior of Early D Gallery, showing westernmost part of its central corridor. The angle of roof and walls due to tilt in remote camera. ©PIACCH

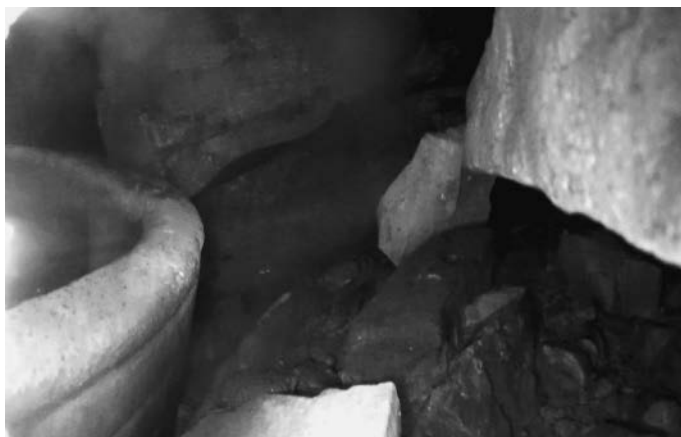
**Figure 2-21** View of doorway-like constriction midway along main Early D Gallery passage, with a centrally placed stone vessel, left. ©PIACCH

drops. This expanded space may be related to an otherwise unknown entrance into the gallery, but this is not clear from the unscaled video alone. The vertical position of the gallery in Building D, 6–8 m below the crest of the building, and the lack of an at-level lateral façade entrance (which are rare at Chavín), suggests that the gallery may date to a period of Building D construction several vertical growth episodes before the building's final Chavín-period additions. Although there is a considerable accumulation of sediment sloping in from some parts of the corridor walls, a relatively large amount of bone and ceramic fragments are also visible in the video documentation. About halfway across the final enlarged segment, a seemingly decorated large stone vessel appears, upright and full of water (Figure 2-21).

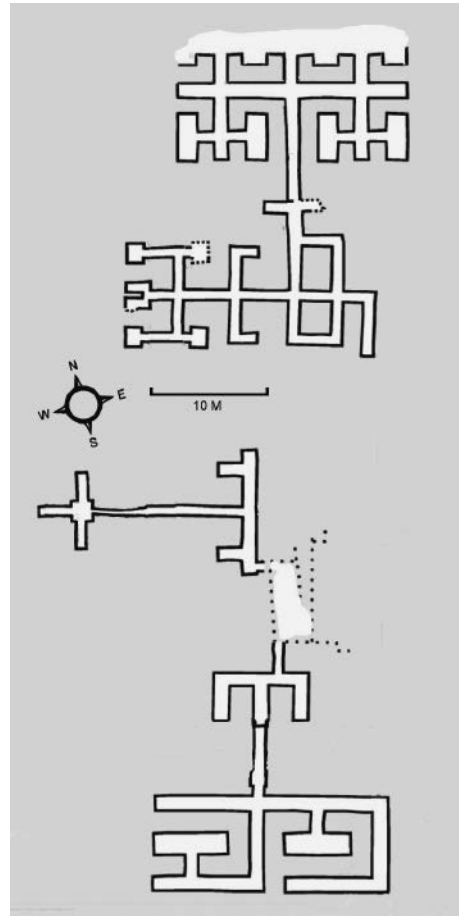
**Figure 2-22** Same scale comparison of floor plans of Loco Gallery (above) and Lanzón/Labyrinth Galleries (below). Adapted from Kembel (2008), courtesy of Silvia Rodriguez Kembel
