Critical Changes in Djenné’s Local Community after Its Nomination as a World Heritage Site: Issues of Preservation and Cultural Conservation

Oussouby Sacko
Kyoto Seika University

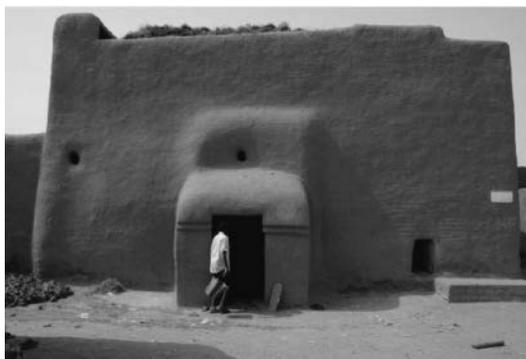
Photo 3 House facade
(Source: the author, Djenné, February 2007)

In 1995 and 1996, joint missions were constituted (Table 1). The missions, acknowledging the special quality of the built space of Djenné, also recognized that if the city had not suffered serious aggression from "modernity," it was in part due to its isolation and the stagnation of economic activity, which were simultaneous causes of the collapse of an alarming number of older structures. It was thus envisaged to undertake a short-term project with the goal of "conserving this unique monument for the present and future generations," which focused on the rehabilitation of 168 of the monumental houses considered to be the most representative of the "national cultural identity." (Joy 2008) The intervention ranges from minor repairs and wall rendering to total reconstruction, based on existing documents or relying on the descriptions of those who remember (Photo 3).

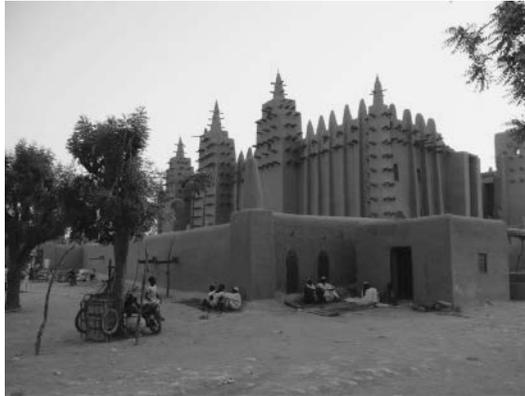
Photo 4 The Great Mosque
(Source: the author, Djenné, March 2011)

Beginning in 2004, under a public-private partnership, the AKTC began to revitalize the center of Djenné. The Great Mosque as well as public spaces around it were repaired (Photo 4). The Mosque restoration became the most visible part of a multidisciplinary program aimed at improving the quality of life in the city. Efforts included the installation of new water and sanitation systems, street paving, early childhood education, training, health care, and economic development. The AKTC's work relied on close cooperation with local institutions and stakeholders and the participation of experienced local masons and specialists in restoration (WHEAP 2012). On October 26, 2008, technical field work was initiated by the AKTC at the request of Mission Culturelle de Djenné and a government body, the Direction National du Patrimoine Culturel (DNPC) in the technical documents (Diagnostic pathologique de la Mosque de Djenné). The local traditional authorities, religious, and administrative authorities had already consented to the project, and there was a publicity campaign for citizens to understand the project and accept the AKTC as the main sponsor.

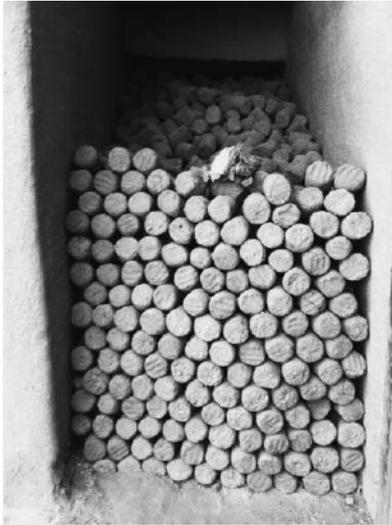
Photo 5 Traditional mud bricks (Djenné Ferey) (Source: the author, Djenné, August 2009)

There are two types of adobe blocks used in Djenné's historical sites. The older type, no longer used except for specific restoration work, is called *Djenné ferey* ("blocks of Djenné") and consists of roughly cylindrical pieces (Photo 5). From the 1930s, it became common to shape the adobe blocks into rectangular forms (*toubabou ferey*, "foreign blocks") (Photo 6). During the dry season, builders transform the riverbanks into pits for the preparation of banco, the material (*labu* or *labou* in Djenné's local dialect *Djenné Chiini*) that forms construction blocks and rendering mortar. Wood is used for the construction of floors, ceilings, and roofs. This wood is also used for *toron*, a natural architectonic material specific to the region.

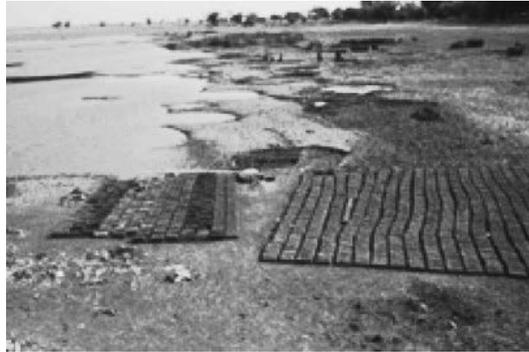
Photo 6 Framed mud bricks in fabrication (toubabou ferey) (Source: the author, Djenné, March 2005)

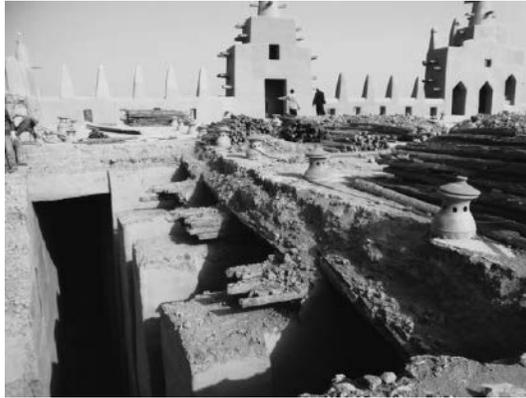
Photo 7 Mosque roof before rehabilitation
(Source: the author, Djenné, August 2009)

For planning the restoration process and understanding the building and construction material problems, some architectural measurements and diagnostics were conducted (Photo 7). For the site installation some preliminary works were done such as bat exclusion, management and storage of material stock and construction of temporary storage space, and rehabilitation of surrounding zones.

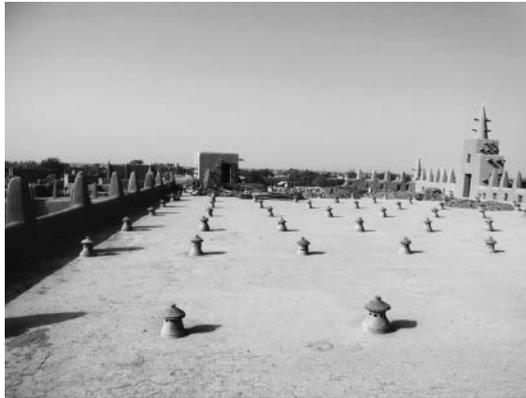
Photo 8 Renovated roof
(Source: the author, Djenné, March 2011)

For site preparation and installation, some zones and temporary spaces were constructed, such as material storage zones, mortar mix zone, wooden trays, and bins storage. Two scaffolding areas were set up north and south of the Great Mosque. For the roof restoration, all beams and *torons*¹⁾ were refurbished, repaired, and replaced (Photo 8).

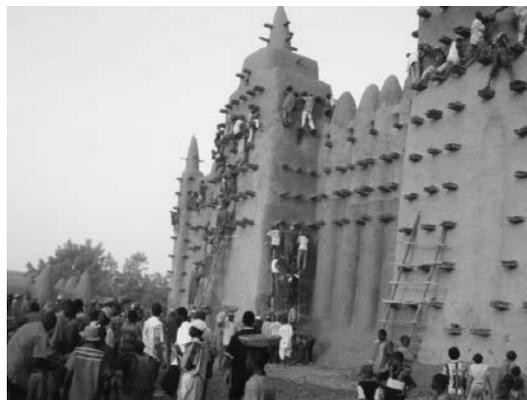
Photo 9 Annual mosque recovering event
(Source: the author, Djenné, May 2004)

But the restoration projects raise some problems, such as the gap between traditional and modern techniques or approaches in construction. Residents mentioned that the AKTC did not keep their promises of providing earthen material for subsequent annual Mosque re-covering festivals (Photo 9). There was also confusion between building workers (masons, *barey ton*) from different generations because younger masons who could read and write were favored, as they could communicate with the foreign experts on site and thus enjoyed more professional advantages than other workers. Another problem was how to respect the traditional procedure of renovation alongside more modern ones. For instance, some local techniques were not preserved during the restoration projects. The restoration and conservation of Djenné and its Mosque also raised the fundamental question of the roles and responsibilities of the local population,
