# Creation of a New National Museum to Meet the Environmental Needs of the Twenty First Century : Kyushu National Museum

著者(英)	Mitsuko Honda
journal or publication title	Senri Ethnological Studies
volume	102
page range	25-37
year	2019-12-09
URL	<a href="http://doi.org/10.15021/00009464">http://doi.org/10.15021/00009464</a>

**Mitsuko Honda**  
*Kyushu National Museum*

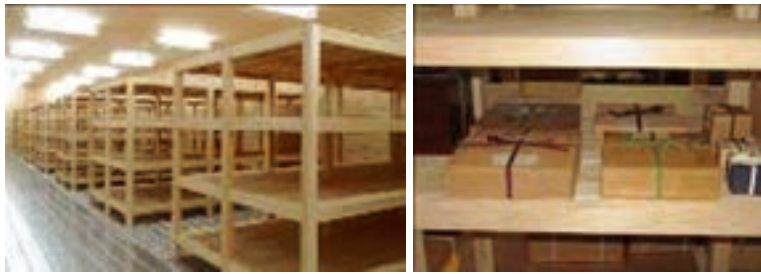
**Photo 5** Storage area shelves (wooden boxes are placed on wooden shelves)  
(Source: Kyushu National Museum, left 2004, right 2005)

double walls and the wood's capabilities, visitors gain an understanding of the Japanese traditions to protect cultural properties based on the wisdom cultivated by the environment. The guides explain that wood helps keep the air humidity constant by absorbing moisture when the surrounding humidity is high and desorbing moisture when it is low and that friction created between the wooden shelves and wooden boxes prevents slippage, which helps mitigate earthquake damage.

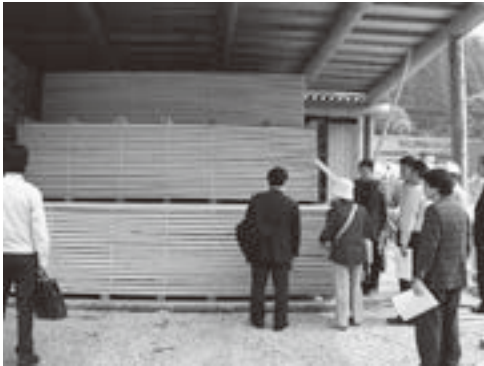
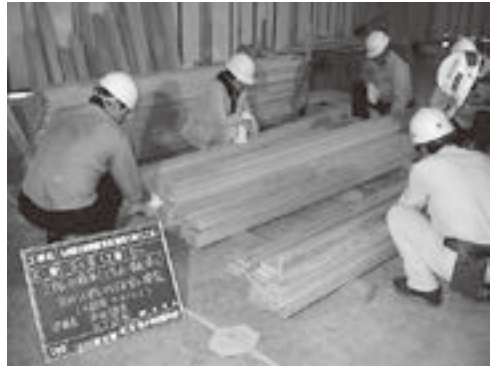
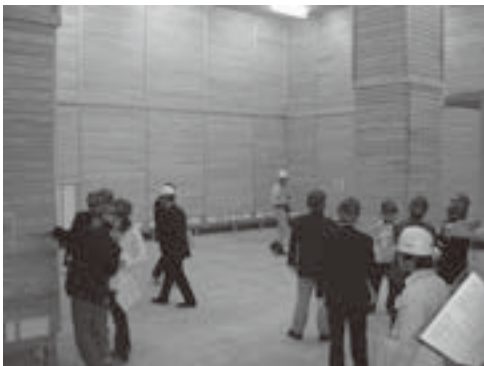
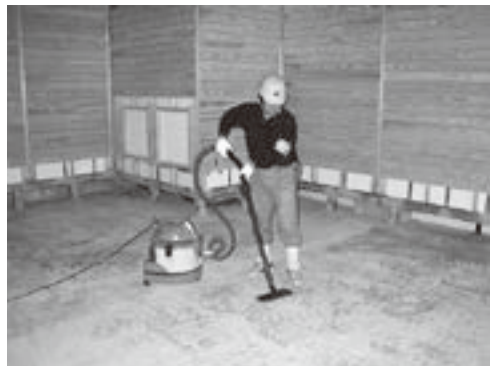
**Photo 6** Inspection and cleaning during construction of the storage area  
(Source: Kyushu National Museum, 2003)

Inspecting wood at the lumber mill

Inspecting before construction

Inspecting during construction

Cleaning after each construction stage

The wood we used had already undergone electrical seasoning during the sawmilling process to completely eliminate pests, eggs, and microorganisms, so we decided to solve this issue by ensuring management and cleanliness during construction. In reality, however, always using clean gloves and carrying out inspections and meticulous cleaning at each stage of construction requires significant labor resources (Photo 6). This would not have been possible without the contractor's understanding and cooperation. The fact that we were able to implement these climate change prevention measures and not use chemicals, thanks to the efforts of so many people, is profoundly meaningful.

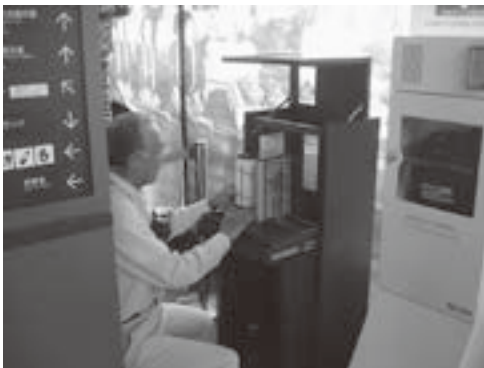
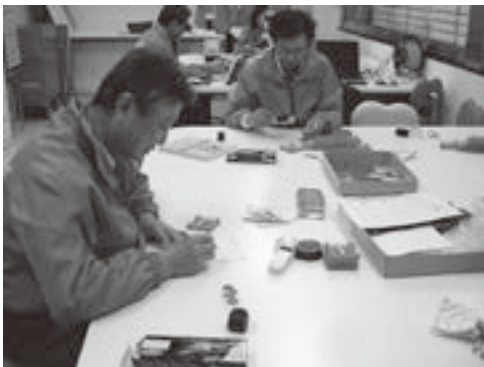
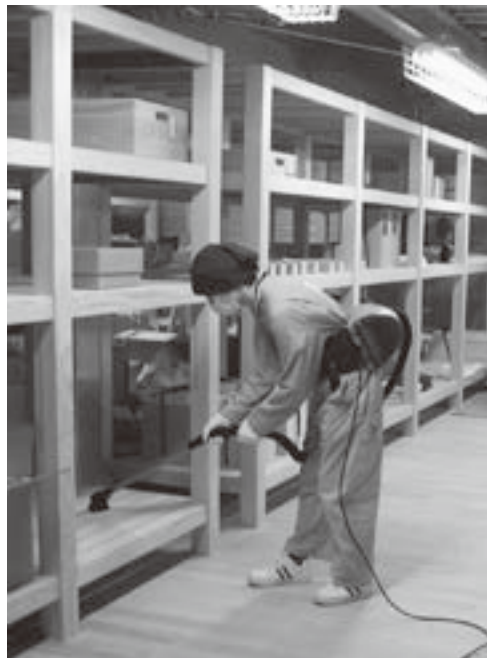
**Photo 8** Supporters of Kyuhaku's IPM operations (Source: Kyushu National Museum, between 2005 and 2011)

Local volunteers (replacing chart paper)

Local NPO staff (replacing pest traps)

Specialized IPM technician carrying out IPM operation in the storage area: cleaning with a vacuum cleaner

Kyuhaku monitors pests by setting around 300 adhesive traps per year. The volunteers prepare the traps every two weeks and set and replace them in visitors' areas such as the exhibition galleries and museum hall. Volunteers also replace chart paper for the hygrothermographs and organize the data. An NPO formed by volunteers performs IPM services in the rooms and the passageway in front of the storage area where cultural properties are not stored. These volunteers also inspect the dust that is collected during IPM operations and the traps collected by other volunteers. Cultural properties on display in the exhibition galleries and hands-on materials are maintained daily by specialized IPM technicians. Technicians are required to have curator certification, and they carry out maintenance operations in the storage area where cultural properties are stored in accordance with the rule that items are not to be touched (Photo 8).

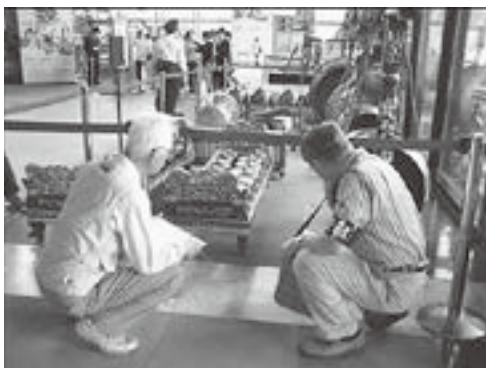
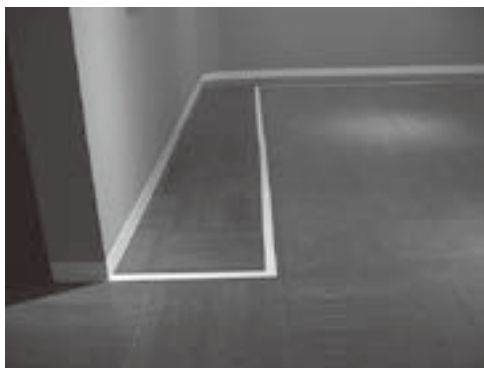
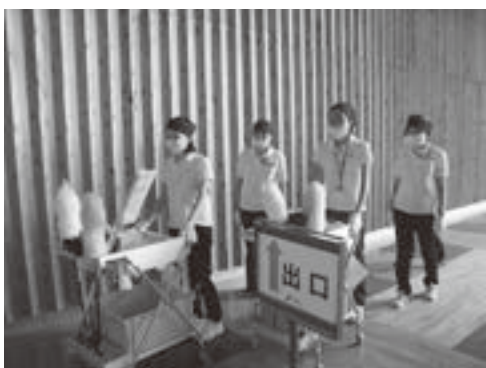
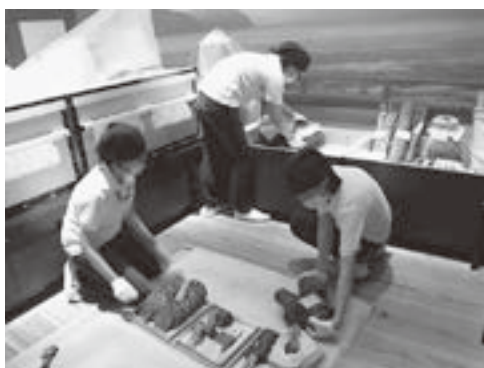
**Photo 9** Countermeasures against dust resulting from the large number of visitors  
(Source: Kyushu National Museum, between 2005 and 2011)

Local volunteers on inspection patrol

Dust on floor in exhibition gallery after closing

Specialized IPM technician maintaining exhibited items

We are grateful that so many people visit the museum, but there are problems that come with this as well. A considerable amount of dust is produced, especially from autumn to early spring, due to garment materials. The museum is cleaned several times per day during times when there are over a few thousand visitors in a single day, but in the evening, after the museum closes, large amounts of dust can clearly be seen on the floor in front of the barrier lines separating the exhibits from the visitors. With this much dust on the floor, we must consider its effect on the exhibited items. This has been a concern since Kyuhaku first opened, which is why we started the special maintenance system mentioned above (Photo 9).
