Critical Changes in Djenné’s Local Community after Its Nomination as a World Heritage Site: Issues of Preservation and Cultural Conservation

Oussouby Sacko
Kyoto Seika University

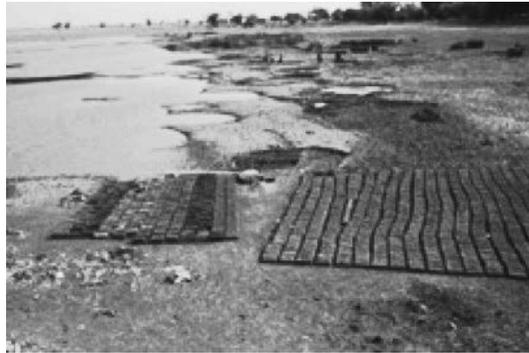
Photo 6 Framed mud bricks in fabrication (toubabou ferey) (Source: the author, Djenné, March 2005)

There are two types of adobe blocks used in Djenné's historical sites. The older type, no longer used except for specific restoration work, is called *Djenné ferey* ("blocks of Djenné") and consists of roughly cylindrical pieces (Photo 5). From the 1930s, it became common to shape the adobe blocks into rectangular forms (*toubabou ferey*, "foreign blocks") (Photo 6). During the dry season, builders transform the riverbanks into pits for the preparation of banco, the material (*labu* or *labou* in Djenné's local dialect *Djenné Chiini*) that forms construction blocks and rendering mortar. Wood is used for the construction of floors, ceilings, and roofs. This wood is also used for *toron*, a natural architectonic material specific to the region.
