## Creation of a New National Museum to Meet the Environmental Needs of the Twenty-First Century: Kyushu National Museum

**Mitsuko Honda**  
*Kyushu National Museum*

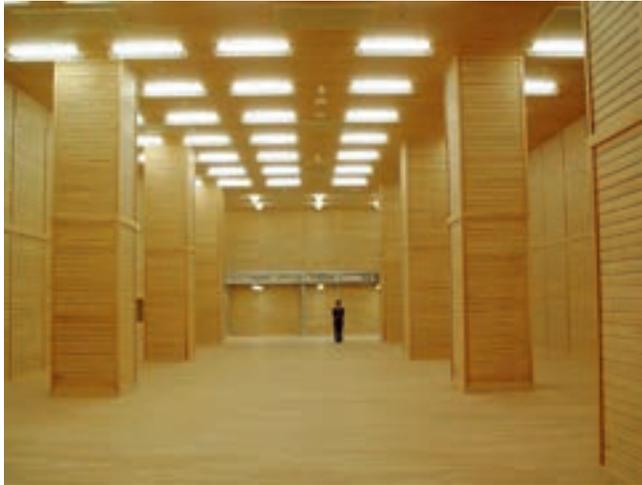
**Photo 4** Storage area (wooden walls, flooring, ceiling, and pillars)  
(Source: Kyushu National Museum, 2004)

Leveraging the experiences, wisdom, and techniques inherited from these traditional methods, we built the storage area mainly out of wood. The outer walls are double-concrete walls with 50 centimeters of space between them. The inner walls, pillars, flooring, and ceiling are made of wood (Photo 4), and wooden shelves and boxes are placed inside (Photo 5). Japanese cedar was used after having been thoroughly dried, and as is traditional with this wood in building storerooms, the lighter colored sapwood was used rather than the red heartwood of the center of the tree due to the fact that it has comparatively fewer volatile organic compounds.

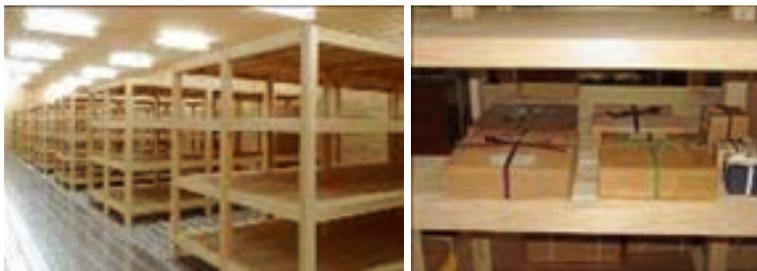
**Photo 5** Storage area shelves (wooden boxes are placed on wooden shelves)  
(Source: Kyushu National Museum, left 2004, right 2005)

double walls and the wood's capabilities, visitors gain an understanding of the Japanese traditions to protect cultural properties based on the wisdom cultivated by the environment. The guides explain that wood helps keep the air humidity constant by absorbing moisture when the surrounding humidity is high and desorbing moisture when it is low and that friction created between the wooden shelves and wooden boxes prevents slippage, which helps mitigate earthquake damage.

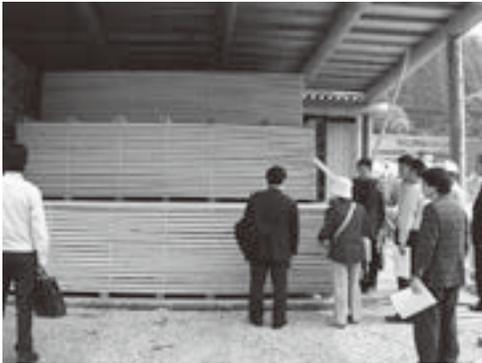
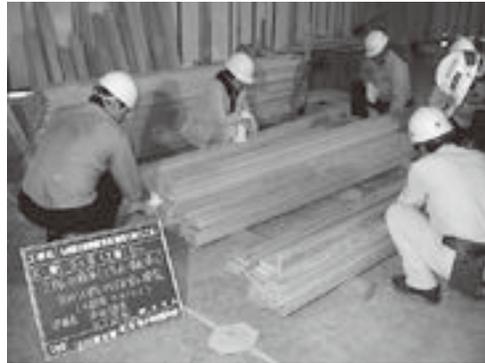
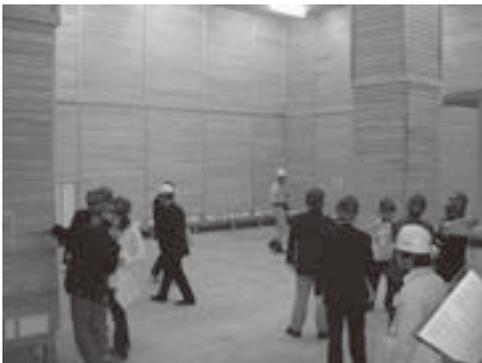
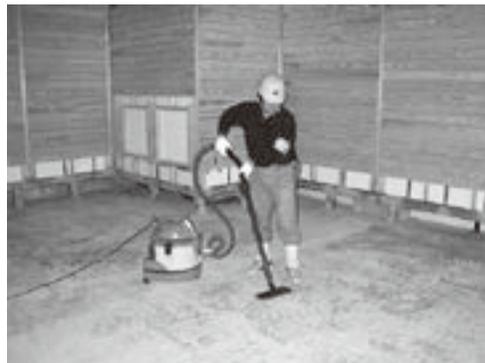
Inspecting wood at the lumber mill

Inspecting before construction

Inspecting during construction

Cleaning after each construction stage

**Photo 6** Inspection and cleaning during construction of the storage area  
(Source: Kyushu National Museum, 2003)

The wood we used had already undergone electrical seasoning during the sawmilling process to completely eliminate pests, eggs, and microorganisms, so we decided to solve this issue by ensuring management and cleanliness during construction. In reality, however, always using clean gloves and carrying out inspections and meticulous cleaning at each stage of construction requires significant labor resources (Photo 6). This would not have been possible without the contractor's understanding and cooperation. The fact that we were able to implement these climate change prevention measures and not use chemicals, thanks to the efforts of so many people, is profoundly meaningful.

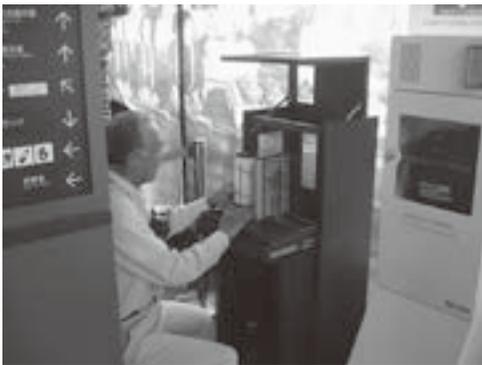
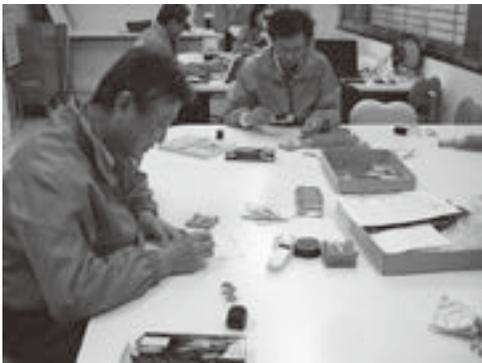
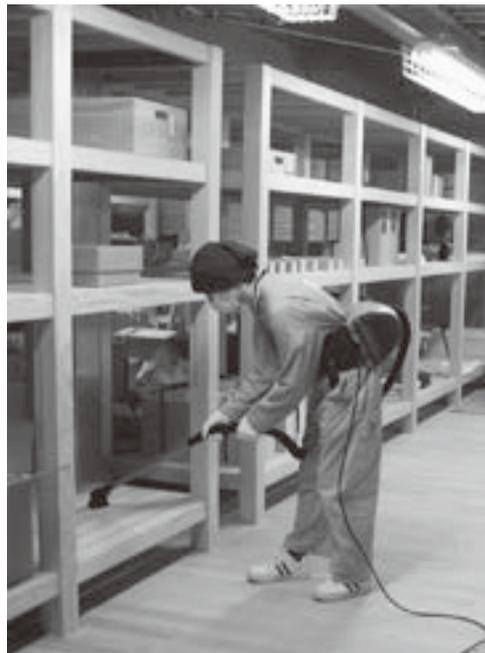
**Photo 8** Supporters of Kyuhaku's IPM operations (Source: Kyushu National Museum, between 2005 and 2011)

Local volunteers (replacing chart paper)

Local NPO staff (replacing pest traps)

Specialized IPM technician carrying out IPM operation in the storage area: cleaning with a vacuum cleaner

Kyuhaku monitors pests by setting around 300 adhesive traps per year. The volunteers prepare the traps every two weeks and set and replace them in visitors' areas such as the exhibition galleries and museum hall. Volunteers also replace chart paper for the hygrothermographs and organize the data. An NPO formed by volunteers performs IPM services in the rooms and the passageway in front of the storage area where cultural properties are not stored. These volunteers also inspect the dust that is collected during IPM operations and the traps collected by other volunteers. Cultural properties on display in the exhibition galleries and hands-on materials are maintained daily by specialized IPM technicians. Technicians are required to have curator certification, and they carry out maintenance operations in the storage area where cultural properties are stored in accordance with the rule that items are not to be touched (Photo 8).

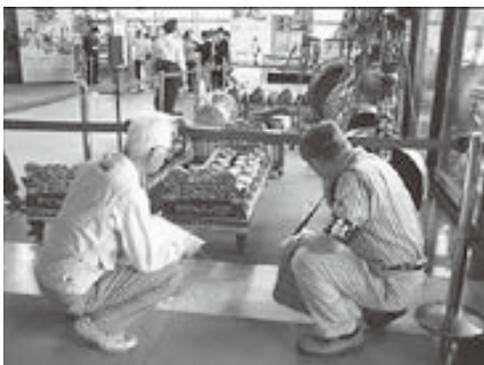
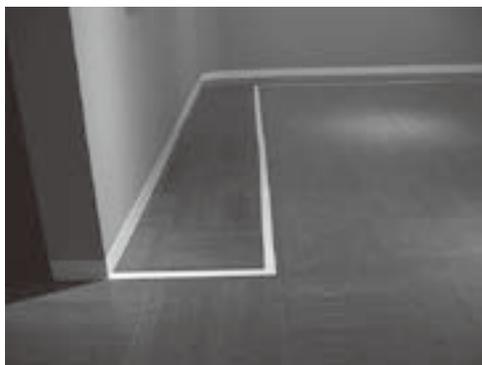
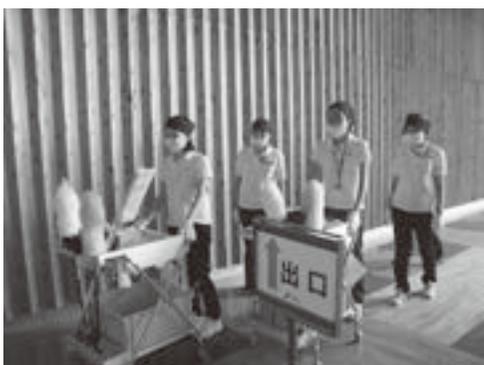
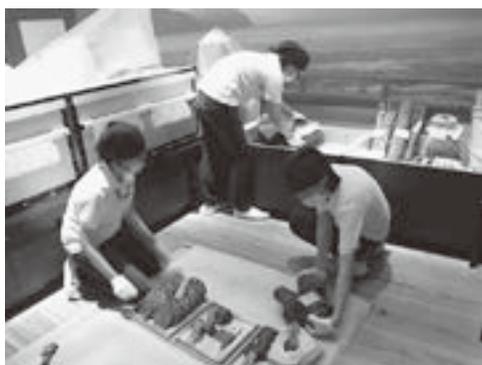
**Photo 9** Countermeasures against dust resulting from the large number of visitors  
(Source: Kyushu National Museum, between 2005 and 2011)

Local volunteers on inspection patrol

Dust on floor in exhibition gallery after closing

Specialized IPM technician maintaining exhibited items

We are grateful that so many people visit the museum, but there are problems that come with this as well. A considerable amount of dust is produced, especially from autumn to early spring, due to garment materials. The museum is cleaned several times per day during times when there are over a few thousand visitors in a single day, but in the evening, after the museum closes, large amounts of dust can clearly be seen on the floor in front of the barrier lines separating the exhibits from the visitors. With this much dust on the floor, we must consider its effect on the exhibited items. This has been a concern since Kyuhaku first opened, which is why we started the special maintenance system mentioned above (Photo 9).
